Delaware Annual Beach Change Report: Ocean Coast

Delaware Department of Natural
Resources and Environmental Control

Division of Watershed Stewardship
Shoreline and Waterway Management
285 Beiser Blvd., Suite 102
Dover, DE 19904
302-739-9921

October 2023

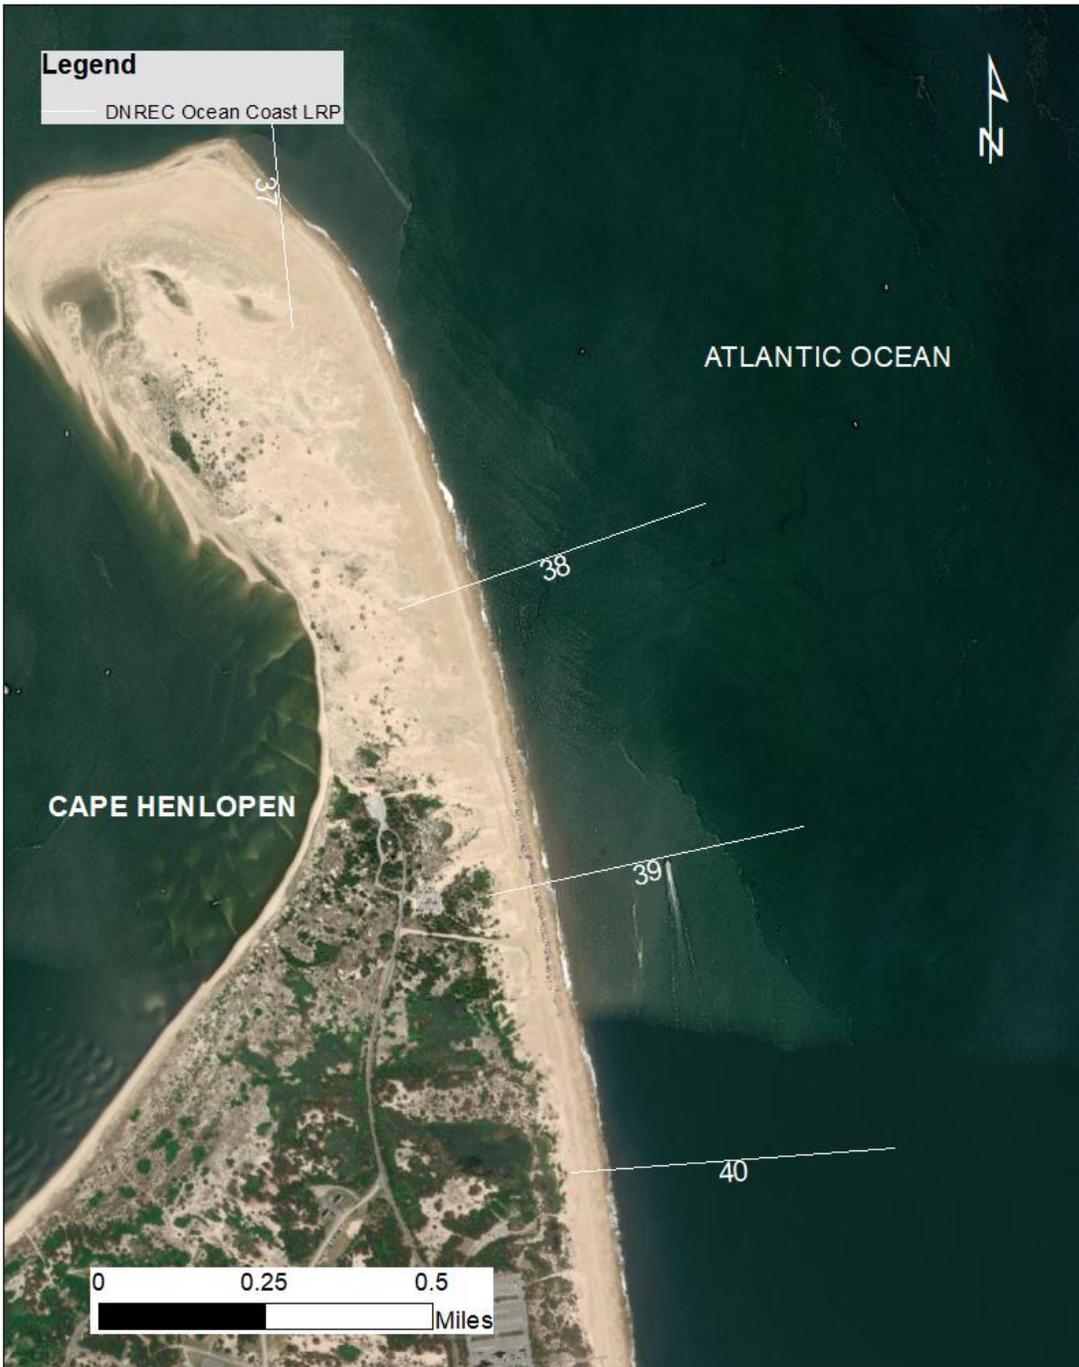
Figure 31: LRP location in the northern portion of Cape Henlopen State Park

The main day-use area is north of Herring Point in Cape Henlopen State Park. This portion of the park contains four survey lines; the two northernmost lines on the spit are sometimes inaccessible due to closures for piping plover nesting.

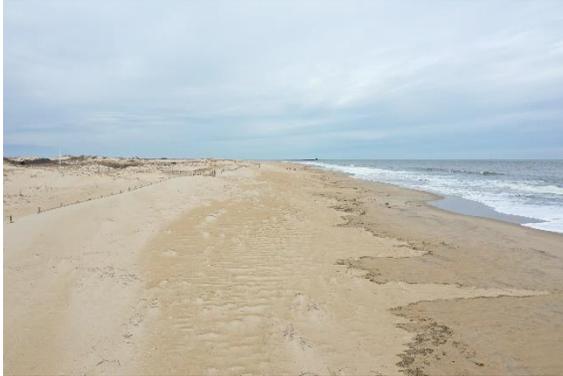
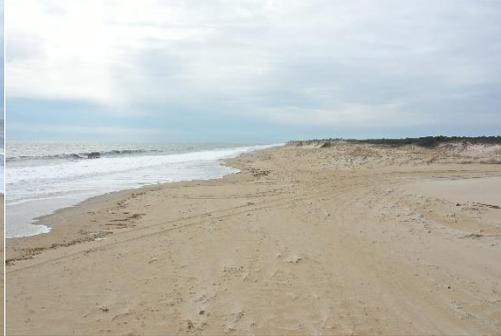
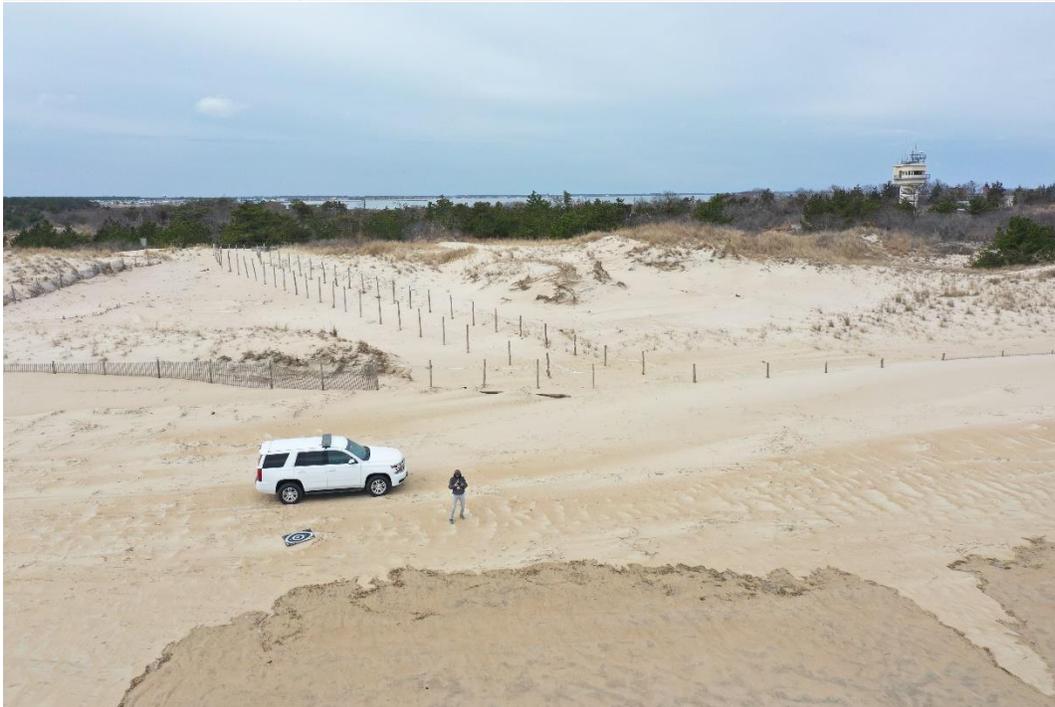
LRP39: (09:45)

Beaches north of the Indian River Inlet were flown on 03/10/2023. During the flight there was a storm surge of about 1.5'. The measured water level during this date is shown in green whereas the predicted tides are in blue. Refer to this water level time series when assessing the photos to understand the tidal conditions at the time of flight.

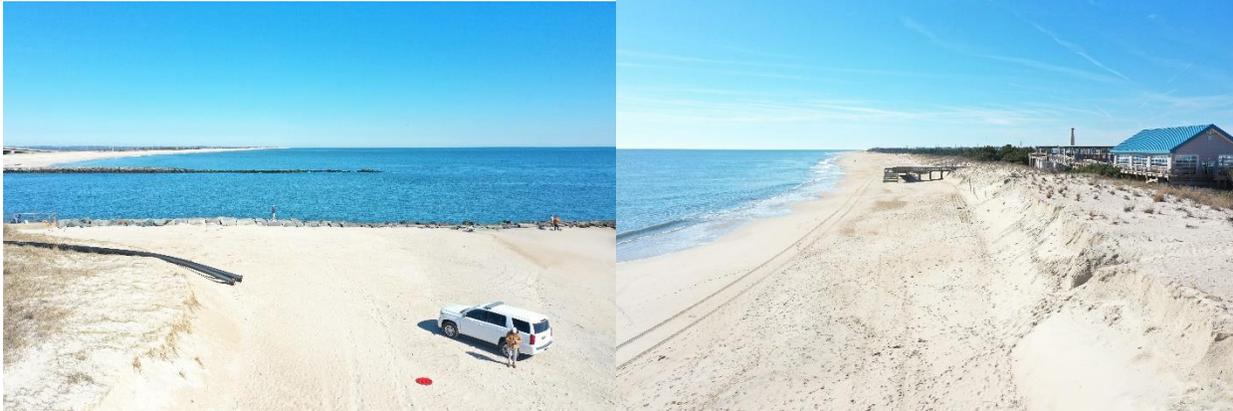
LRP55: (10:42)

Beaches south of the Indian River Inlet were flown on 03/21/2023. During the flight there was little to no non-tidal residual. The measured water level during this date is shown in green whereas the predicted tides are in blue. Refer to this water level time series when assessing the photos to understand the tidal conditions at the time of flight.
